MARINE FOULING ORGANISMS IN MONTEREY  
HARBOR, CALIFORNIA, JUNE THROUGH  
SEPTEMBER, 1966

THOMAS LEROY MILLER

MASTER OF SCIENCE IN OCEANOGRAPHY

UNITED STATES NAVAL POSTGRADUATE SCHOOL  
October 1966

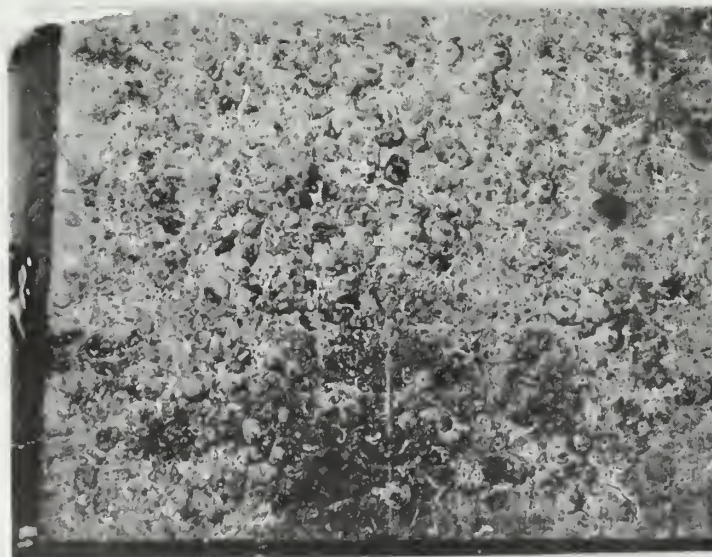
Figure 14. Photograph of Fouling on Steel Panel in Deep Rack Exposed for 90 Days.
